## 2018 > G 2.0 T-GDI > G 2.0 T-GDI > Manual Transaxle System > Manual Transaxle Control System > Simifitsh Lever > Repair procedures

## REMOVAL

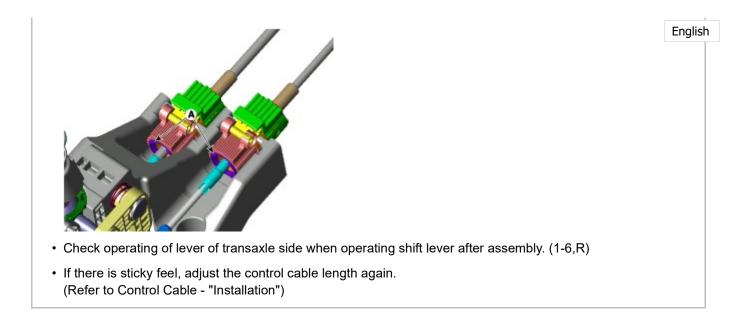
- New shift lever assembly is mounted in the 4th fixing pin. After installation, remove the 4th fixed pin.
- After installing the select cable and shift cable socket, check portion (A) to see if it projects outwards from the cap.
